## Tumbling Test

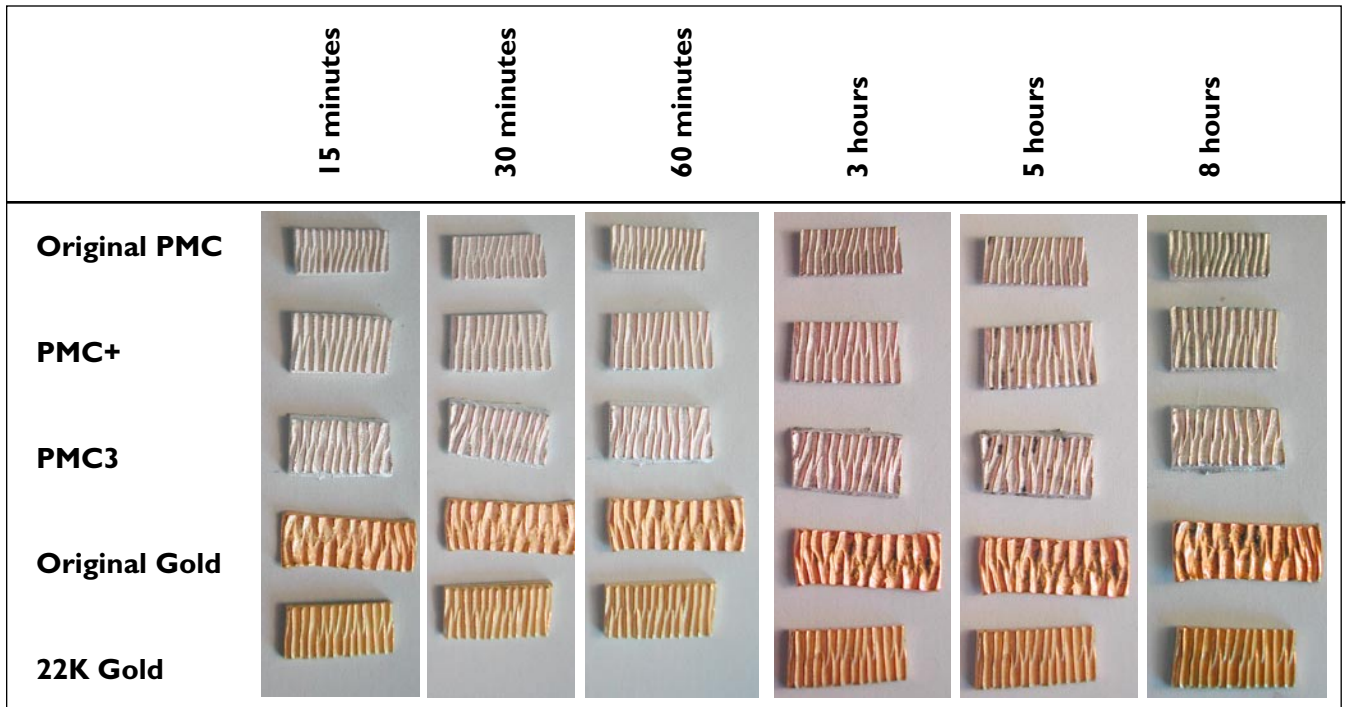
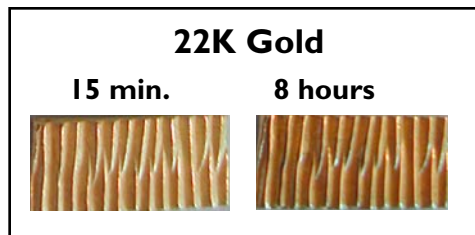
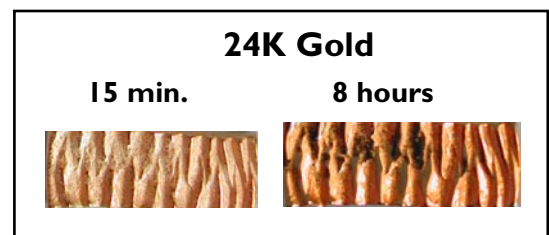
The goal of this test was to determine the wear resistance of the various types of PMC. Stainless steel shot was used to simulate the bumps of everyday life. The tests showed relatively little degeneration in the silver versions, all of which behaved about the same. The new 22K PMC Gold held up very well, as shown in the detail below. The sample of Original 24 Gold PMC became stretched and lost the crispness of the form.
